Real Estate Inspection Report

1234 Main St., Fort Collins, CO

Inspection Date:
10/22/2003

Inspection Report Number:
031022-A

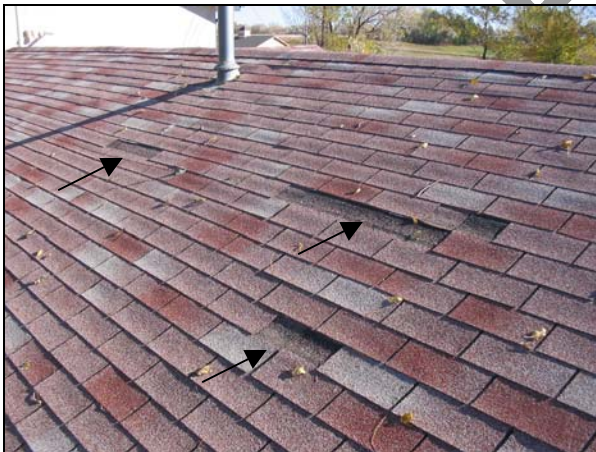
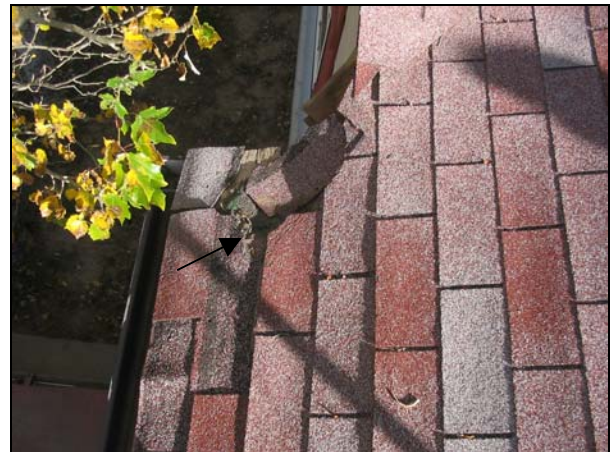
- **Repair:** Repairs to the roofing are needed. Damaged or missing roofing material (approximately 24 individual shingles visible at time of inspection) should be replaced to protect the underlying roof sheathing and to protect against leaks. A qualified roofing contractor should be engaged to perform these repairs.

West slope of the original structure's roof.

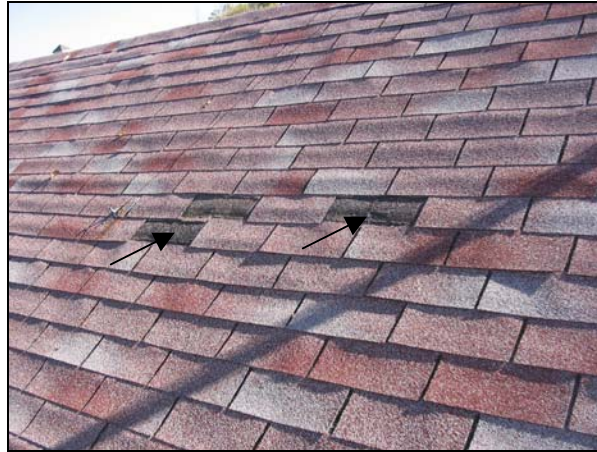
West slope of the detached garage.

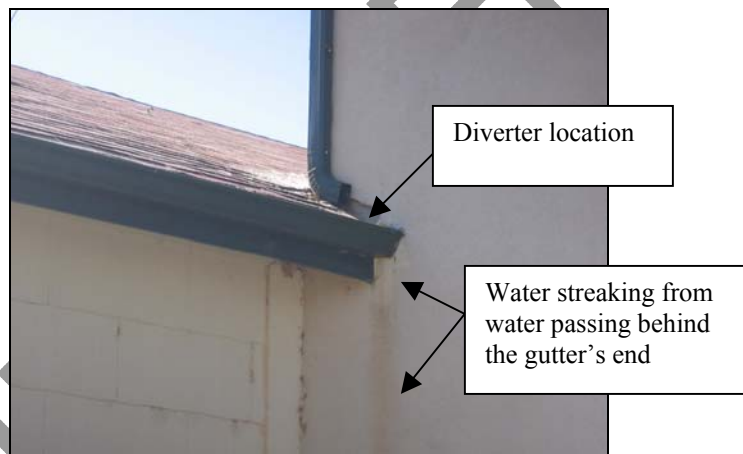
- **Repair:** A diverter flashing should be provided at the southeast addition roof transition to direct storm water into the gutter and minimize saturation of the adjacent stucco siding material.

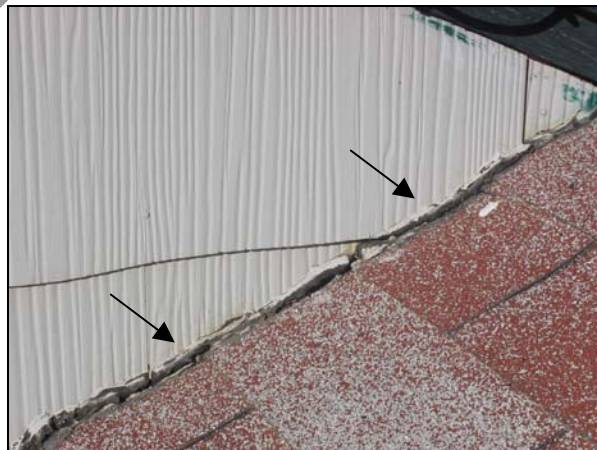
- **Minor Repair:** The roof to siding transition at the west side of the dining room should be flashed and/or sealed to reliably protect against storm water entering at this location.

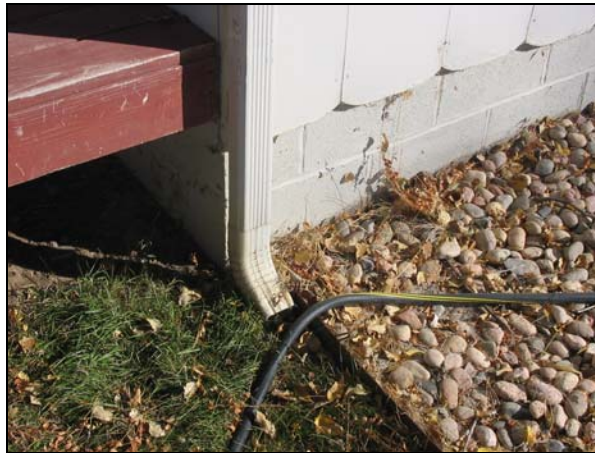
- **Minor Repair:** The gutters need cleaning to reliably deliver storm water to the downspouts and deter overflowing that can damage the fascia (the wood member that the gutters are attached to) soffit and siding.
- **Minor Repair:** All downspouts should be fitted with extensions sufficient to discharge water at least six (6) feet from the house. Storm water should be encouraged to flow away from the building at the point of discharge

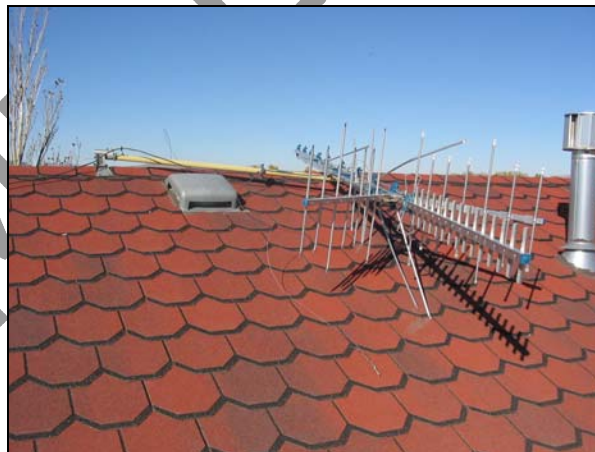
- **Minor Repair:** The antenna at the addition roof has been damaged and should be reattached or removed.

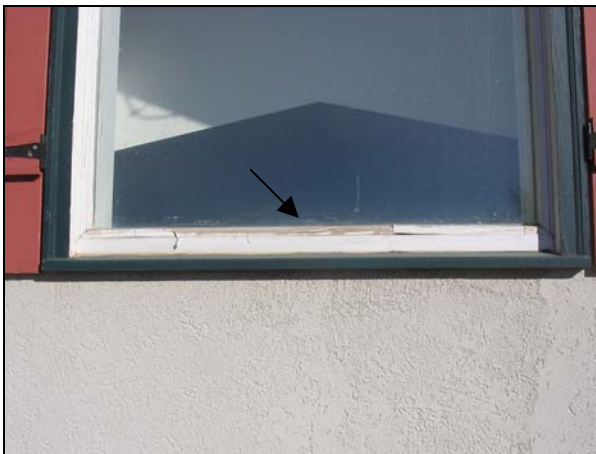
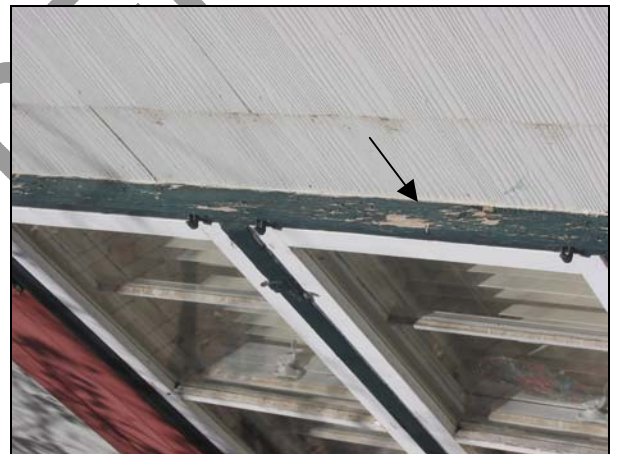
- **Repair:** While it is not critical at this point, the exterior of the home needs painting of the siding and trim to adequately protect against weather damage.

Window trim paint is peeling at various locations.

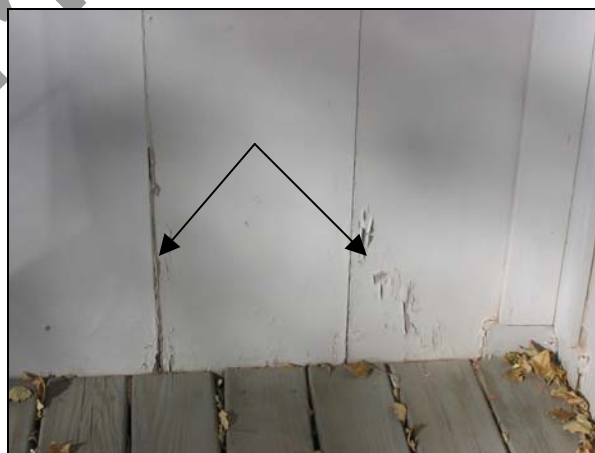
Peeling paint at the front entry.

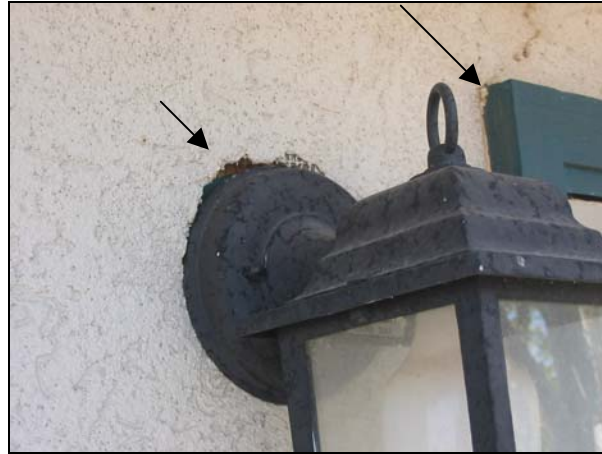
- **Repair:** All penetrations (lighting, electrical, plumbing, and mechanical, etc.) in the EIFS siding should be sealed to protect against possible water intrusion and damage to the underlying wood elements.
- **Repair:** All door and window frame transitions to the EIFS siding should be sealed to protect against possible water intrusion and damage to the underlying wood elements.

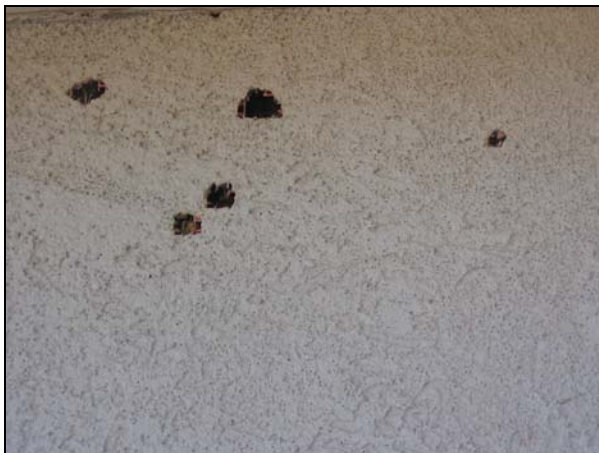
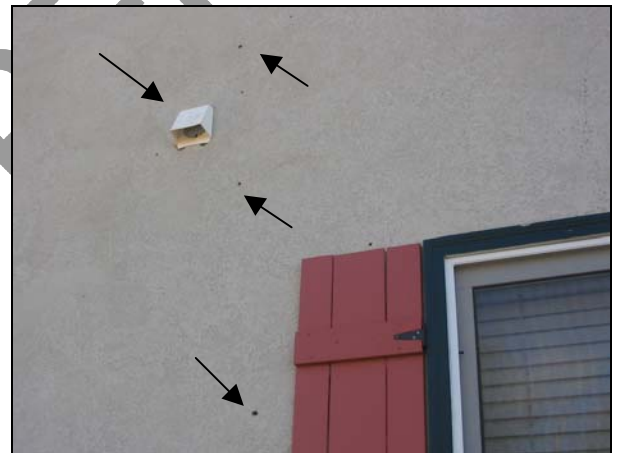
- **Repair:** Localized minor damage of the exterior stucco walls should be repaired. There is risk of hidden or further damage in these areas. A stucco repair contractor should be consulted as to the extent of the damage and the necessary repairs.

Holes in the stucco material at the north and west sides of the addition.

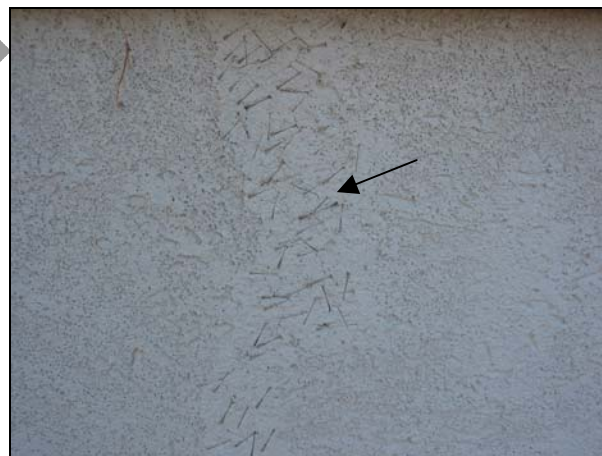
Evidence of previous repairs to surface cracking at the west wall of the addition.

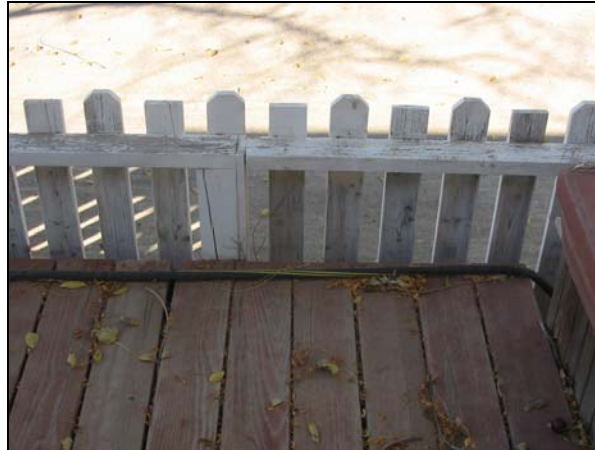
- **Minor Repair:** The deck should be stained, sealed or painted to improve its durability.
- **Improve, Safety Issue:** Although not high enough to require one, a railing should be provided for the deck at the west side of the home to assure safe and reliable protection against accidental falls. The adjacent fence has created a tripping hazard.

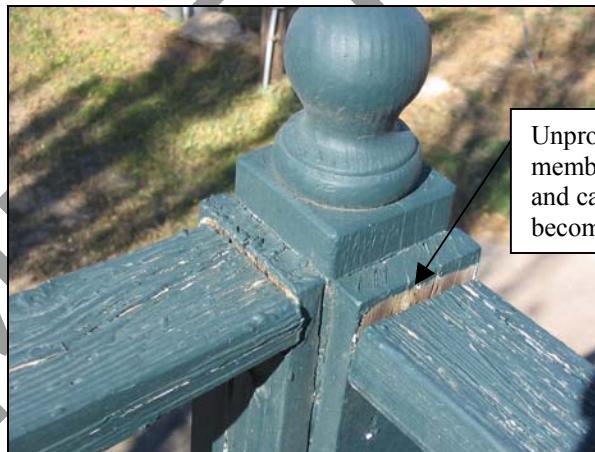
- **Repair, Safety Issue:** The master bedroom deck railing is loose and needs repair to assure safe, reliable protection.

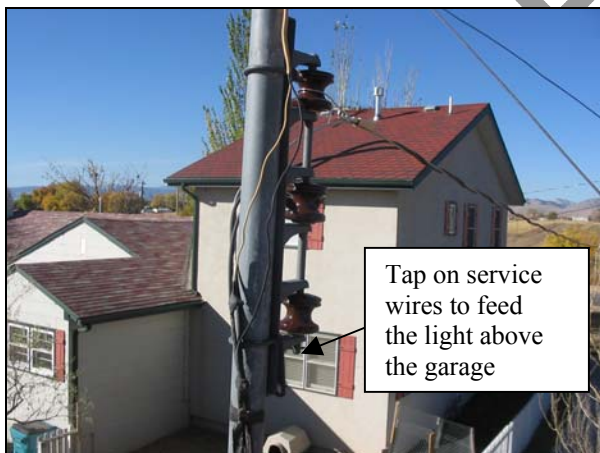
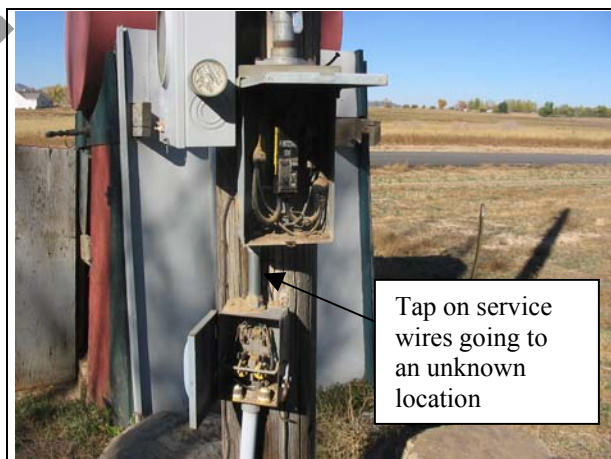
- **Repair, Safety Issue:** Electrical wiring tapped directly to the main service should be removed. All circuits should be connected at the electrical panel where they can be protected by a properly sized and dedicated circuit breaker.

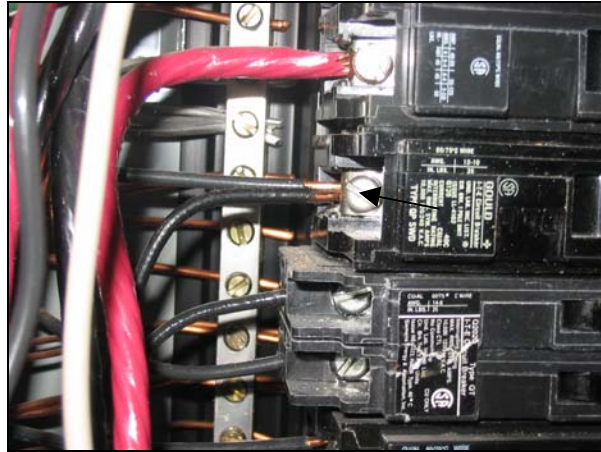
- **Repair, Safety Issue:** A circuit breaker in the garage electrical panel has been “double tapped” – 2 wires fed into a single breaker. A separate circuit breaker should serve each wire/circuit. Double tapped breakers risk poor connections of the wires that can lead to arcing and a fire hazard. The electrical panel and breaker should be further evaluated by a qualified electrician for an acceptable repair of the double tap.

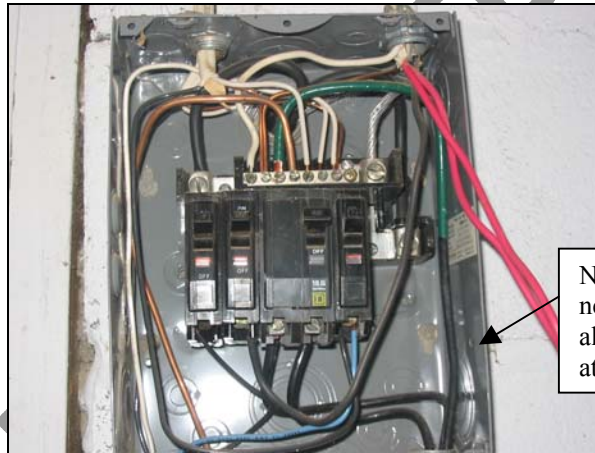
- **Repair, Safety Issue:** Neutral (white) and equipment ground wires (bare copper or green) within the garage electrical panel should be isolated from each other. An additional attachment bar should be installed and these wires separated and attached to their own respective bar.

New ground bar needed for panel and all ground wires attached to it

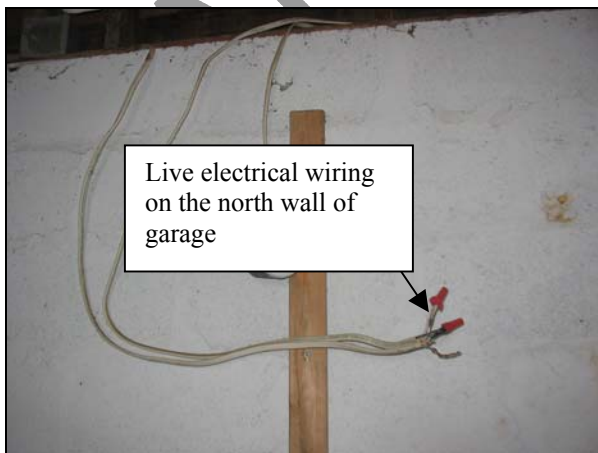
- **Repair, Safety Issue:** Abandoned live wiring in the garage should be removed or appropriately terminated.

Live electrical wiring on the north wall of garage

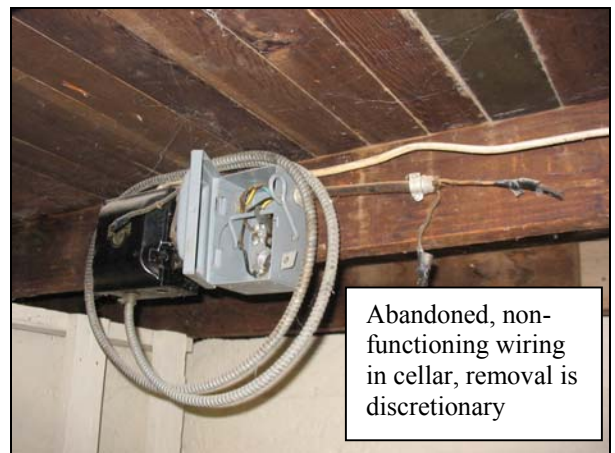
Abandoned, non-functioning wiring in cellar, removal is discretionary

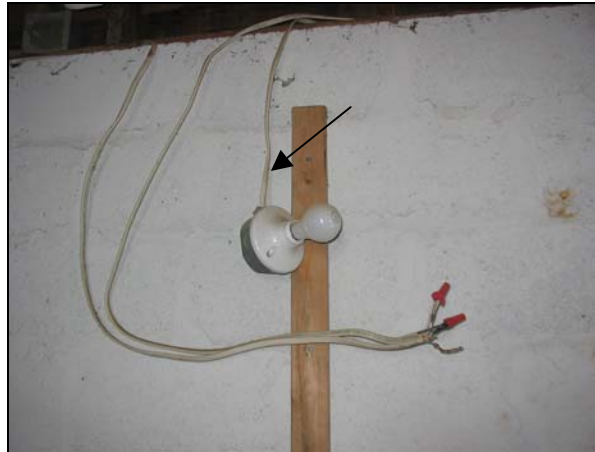
- **Minor Repair:** The light fixture at the garage north wall should not be supported by its wiring. The fixture/box should be connected to adjacent framing to remove stress from the wiring.

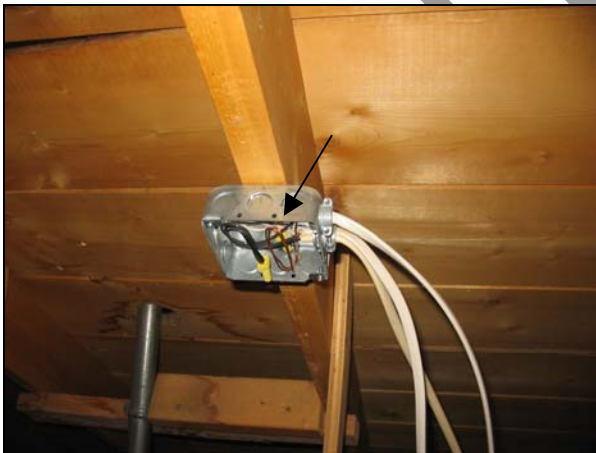
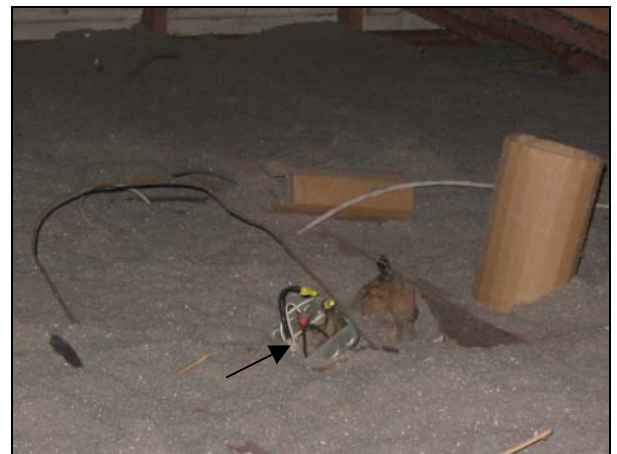
- **Repair, Safety Issue:** Improper electrical splices within the attic should be repaired. All electrical connections should be made inside junction boxes fitted with cover plates.

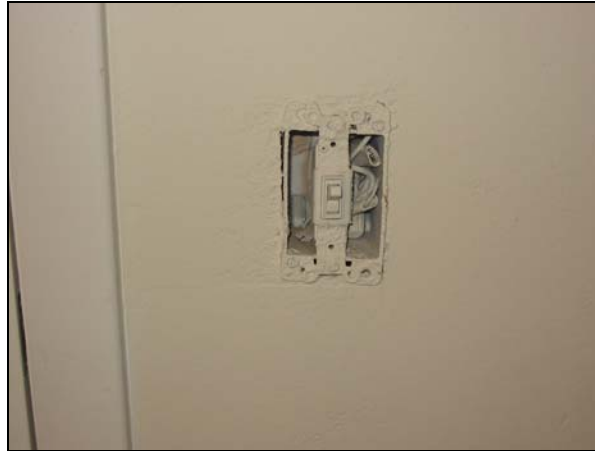
- **Minor Repair, Safety Issue:** Missing outlet cover plates should be replaced to avoid a shock or electrocution hazard.

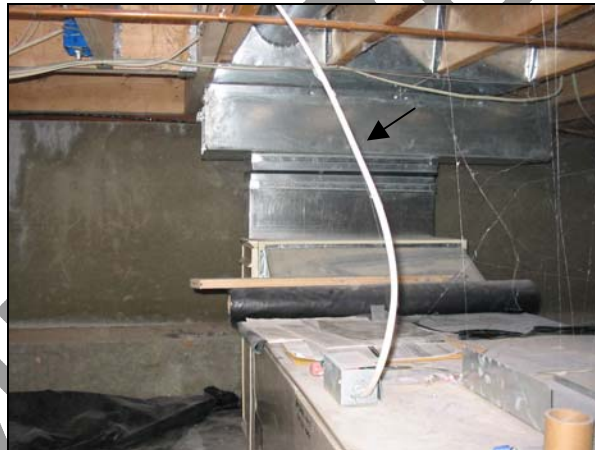
- **Repair:** Exposed furnace supply wiring should be enclosed within a flexible conduit to protect the wiring from physical damage.

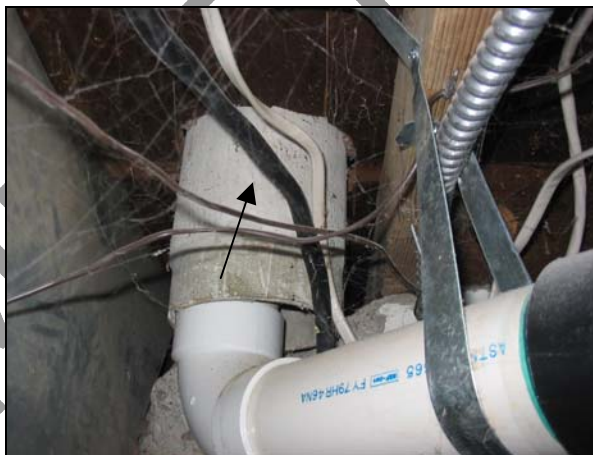
- **Monitor:** The exhaust vent material appears to be enclosed in material possibly containing asbestos. If left undamaged this condition/material presents minimal safety hazards or danger.

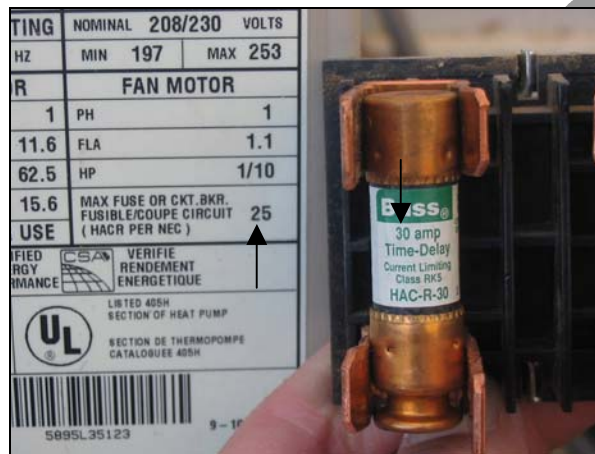
- **Minor Repair:** The 30 amp fuses providing protection to the north air conditioner compressor exceed the manufacture's stated maximum amperage of 25 amps. Replacement with 25 amp fuses is recommended.

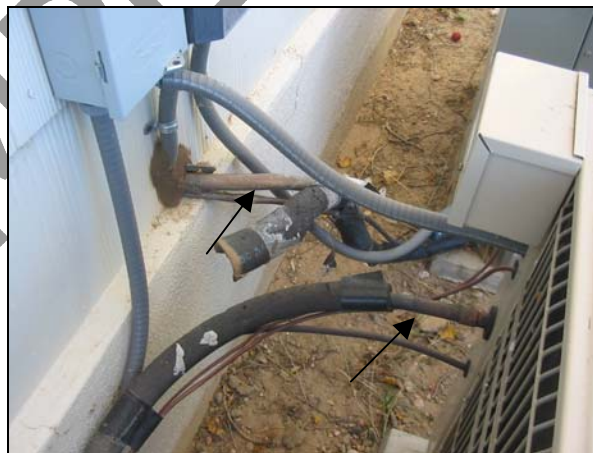
- **Minor Repair:** Damaged insulation on the exterior refrigerant lines should be repaired.

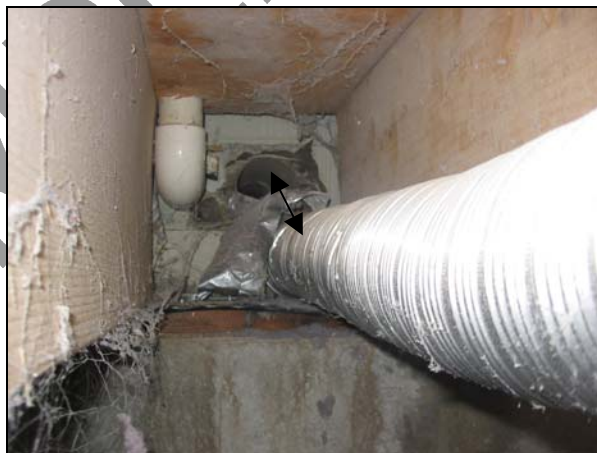
- **Minor Repair:** The clothes dryer duct within the crawlspace is disconnected. This condition risks warm, humid air being deposited within the space, resulting in condensation formation.

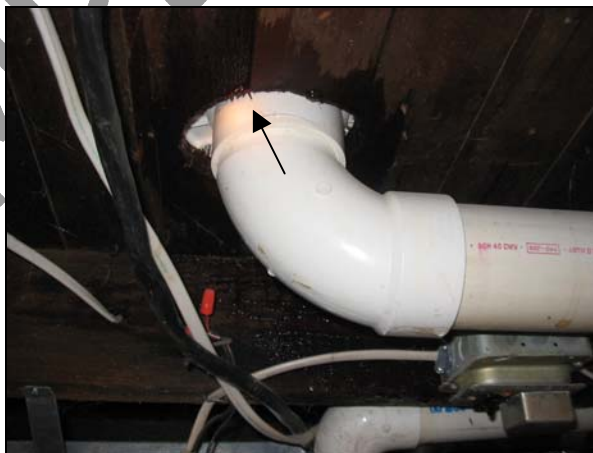
- **Repair:** A water leak is present in the cellar at the location of the main level hall bathroom toilet.

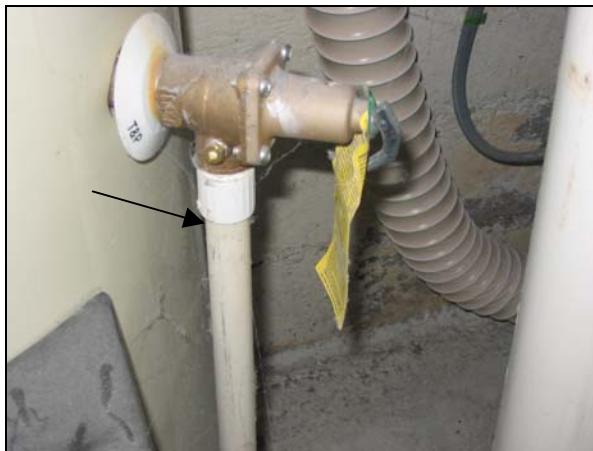
- **Repair, Safety Issue:** The discharge pipe serving the Temperature and Pressure Relief (TPR) Valve for the water heater has been constructed from PVC plastic. PVC plastic is not pressure or temperature rated for the possible extremes inherent with this type of installation. The discharge pipe should be constructed from steel, copper or CPVC plastic for safe, reliable operation.

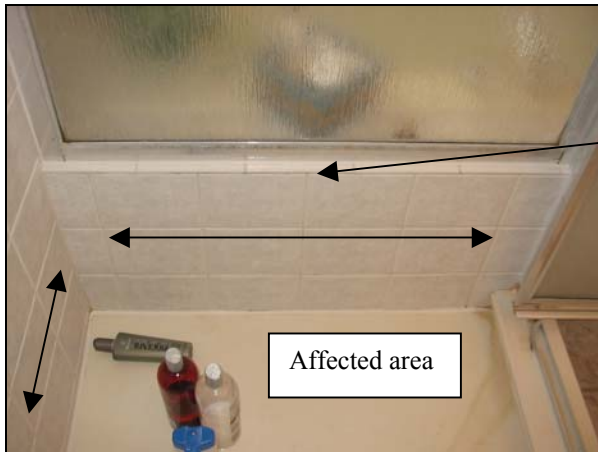
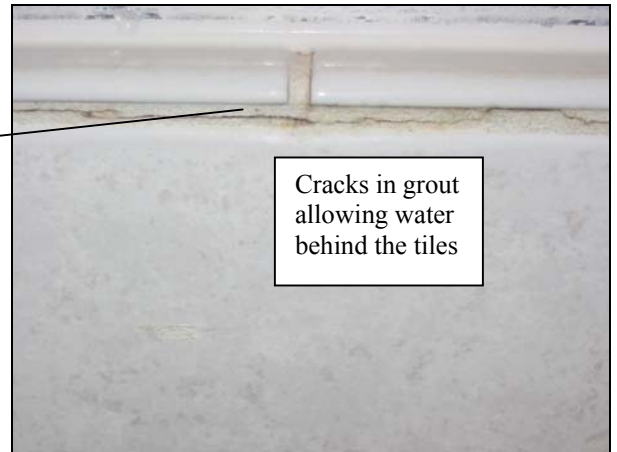
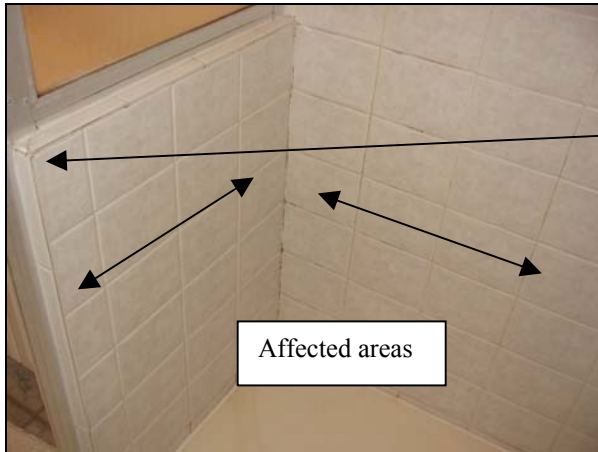
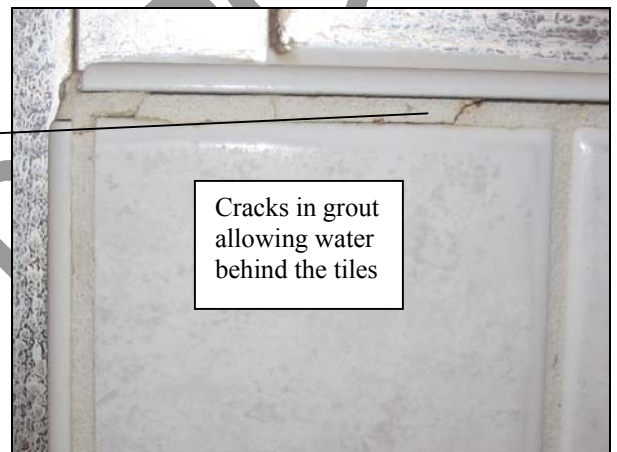
- **Repair:** The tile shower stall enclosure at the master bathroom requires repair. Loose or damaged tile, grout and caulk should be repaired or replaced as necessary. Any damage to the wall behind the tile should also be repaired (if necessary). Moisture meter readings taken at the time of inspection revealed elevated moisture levels behind tiled surfaces. A qualified tile repair contractor should be engaged to further diagnose the extent of damage and perform any required repairs.

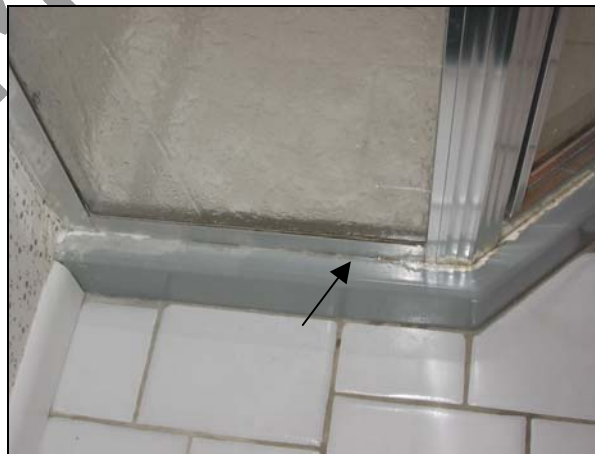
- **Repair:** The shower door at the west bathroom is leaking and should be recaulked as necessary to reliably contain shower water.
